# Manhole Inspection Summary

# Manhole # S21M\_\_035MH

Insp Date: **4/1/08 11:25 AM**

**Location** Address: **425 s payson-s monroe alley**

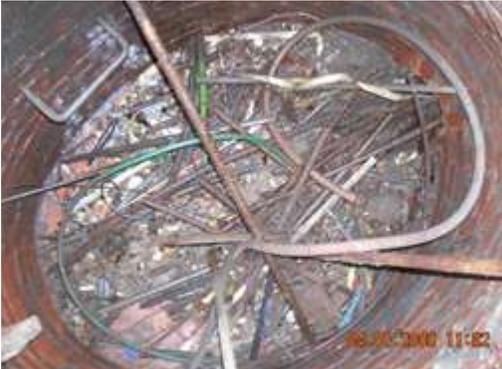
Defect 1

Condition:  Sound  Cracked  Root Intrusion  Deteriorated  Leaks  **Debris**

debris in terminal channel

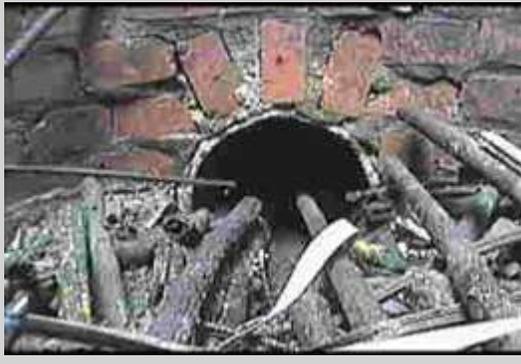
12 O'Clock Outflow

8 in. Circular Gravity Sewer  
Pipe Out @ 12 O'Clock

Pipe Height: **8.4** (in.) Rod and Bar (Angled)  
Pipe Material: **Clay**  Pipe Lined  
Invert Depth: **5.26** (ft.) Flow Characteristics: **None**  
Deposits:  None  **Mud**  Sludge  **Debris**  Grease  
Silt Depth: **3** (in.) Deposits Extent: **Medium**  
Infiltration: **None** Pipe Seal Cond: **Sound**
